**2nd CASPIAN INTERNATIONAL
AQUA TECHNOLOGIES**

LATE AUTUMN BLOOM OF POTENTIALLY TOXIC CYANOBACTERIA *PLANKTOTHRIX RUBESCENS* IN THE RESERVOIR VRUTCI (SERBIA)

Abstract: A multipurpose reservoir Vrutci, with traditionally very good quality of water, after more than thirty year of operation, in the second half of December 2013, was a scene of intensive bloom of potentially toxic cyanobacteria *Planktothrix rubescens*, causing disruption of regular water supply to more than 60000 people from the Uzice Municipality, for almost two months. Everything happened in a short period of time, and consumers and relevant institutions were taken by surprise. However, careful examination of activities in the watershed feeding the reservoir had revealed scores of mismanagement, like illegal urbanization, excessive hydropower utilization, untreated waste water, ilegal fishing etc. Most of them were noticed by the Public Water Supply Utility of Uzice and reported to higher instances, but without timely (re)action. The paper gives the overview of the event, measures undertaken to overcome the problem and the lessons learned. Interestingly enough, even during the peak of cyanobacteria bloom, the othe

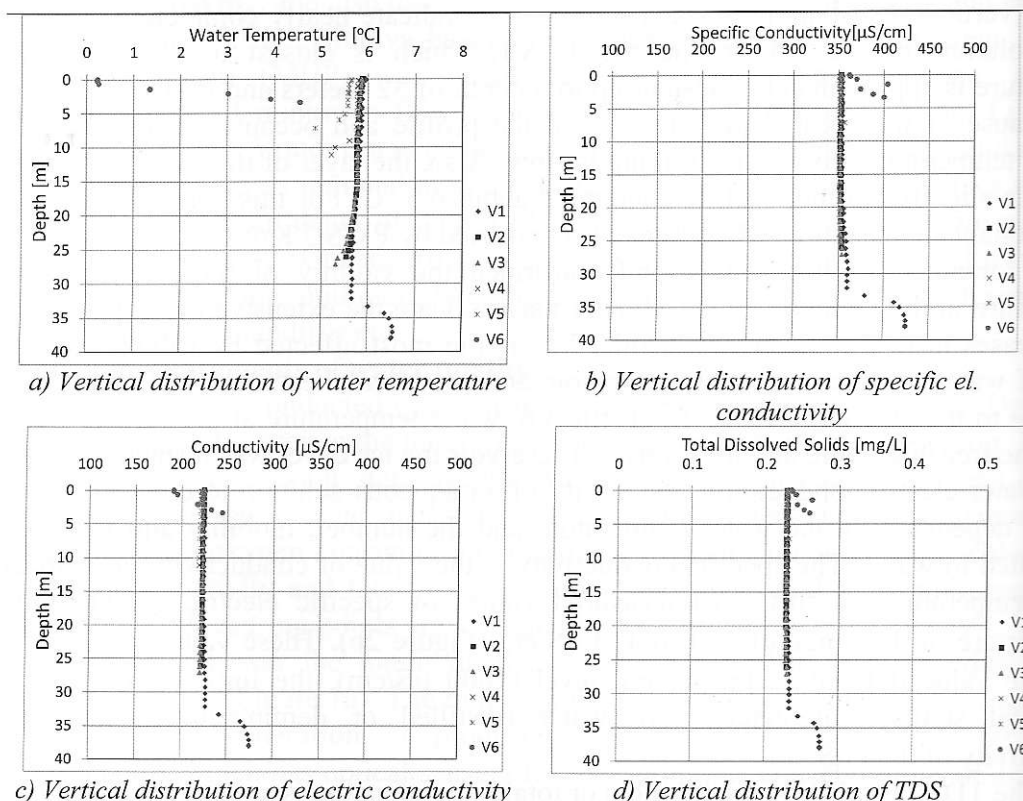
Figure 2. Vertical distribution of: a) water temperature; b) specific e. conductivity; c) electric conductivity and d) Total Dissolved Solids

The measurement results are presented graphically in diagrams (Figure 2 and Figure 3). Data on vertical distribution of water temperature indicate nearly completely mixed vertical water column (Figure 2a). In the profile V1, which is closest to the dam, the water temperature is approximately constant up to a depth of 32 meters and is slightly less than 6.0 °C. Because of the great depth of water at the profile and because of the relatively high ambient temperature, convective mixing is slow. Also, the layer of the water column near the bottom is slightly warmer with temperatures about 6.5 °C. For this phenomenon we do not have a reliable explanation. Measurements conducted by PWSU Krusevac and by the Institute "Batut", obtained similar values, and confirmed the validity of measurement. Increased temperature in the vicinity of the sediment may indicate the extensive biological degradation that releases heat. The upstream profile, V6, is the most affected by tributaries. The small mass of water in this part of the reservoir and the small heat capacity, cause the fastest response to the external forcing. In profile V6, water temperature at the surface was slightly above the freezing point, and in this part of reservoir the ice cover was formed.

Water electro-conductivity, the ability of an aqueous solution to conduct electricity, is directly dependent on the water temperature and the number, mobility and valence of ions dissociated in water. The specific conductivity is the value of conductivity normalized at the water temperature of 20°C. All measured values of specific electric conductivity in the reservoir are in the range of 350 to 430 $\mu\text{S}/\text{cm}$ (Figure 2b). These values are much smaller than the value defined as the natural level (1000 $\mu\text{S}/\text{cm}$), the limit for the first class of ecological status. Completely pure water (distilled or demineralized) has a specific conductivity of 0.05 $\mu\text{S}/\text{cm}$.

determine TDS is gravimetric, it is possible to relate it with the electro conductivity. Due to the almost complete mixing of the lake water in that period, the standard deviations of all the measured parameters are small. Total dissolved solids range in the narrow band of 220 to 260 mg/L (Figure 2d), which is smaller than the concentration of 1000 mg/L, or natural level, the boundary between the first and second classes of ecological status. Increased concentration of dissolved solids were observed just above the sediments at the location of V1, where the temperature is increased and concentration of oxygen is low, which indicate the intense process of degradation of the organic substances.

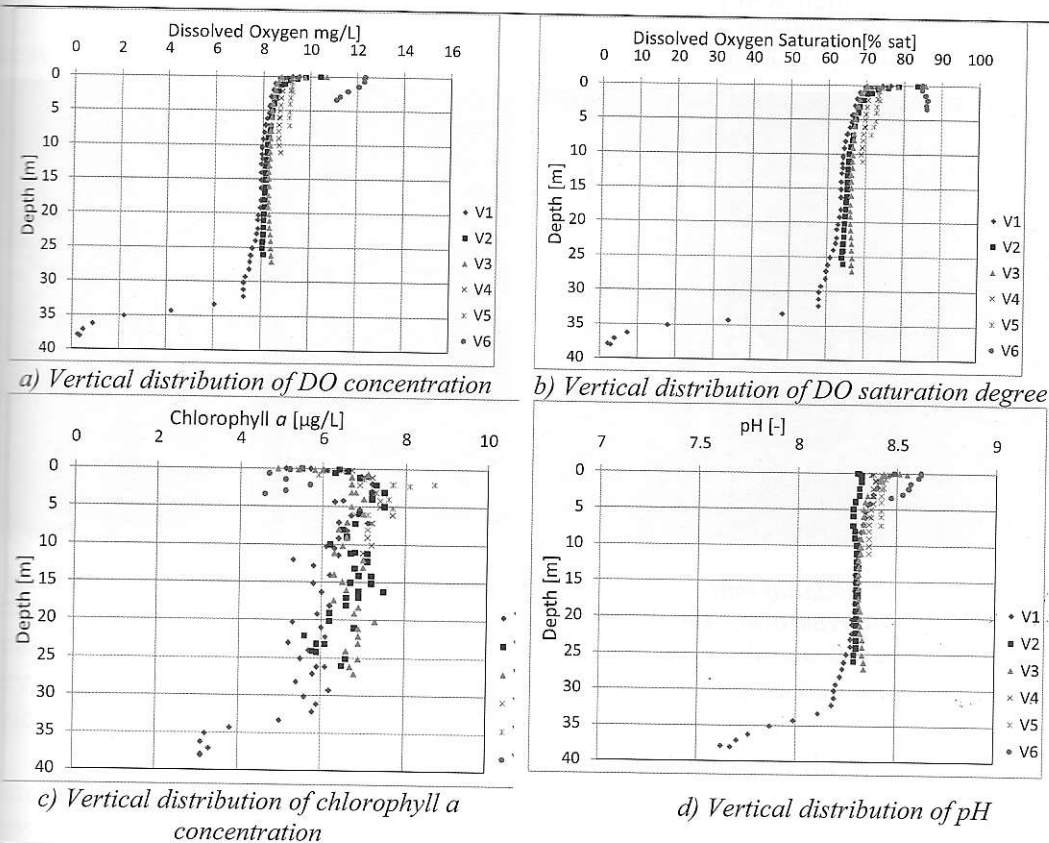
Figure 3. Vertical distribution of: a) dissolved oxygen (DO) concentration; b) DO saturation degree; c) concentration of chlorophyll *a* i d) pH value.

At the time of measurement the Vrutci Reservoir was relatively rich in dissolved oxygen. In over 80 % of measured points in the concentration ranged between 8 and 10 mg/L (Figure 3a). For given water temperature and the corresponding height of the water column, this concentration range corresponds to the degree of saturation between 60 and 80 % (Figure 3b). The presence of significant amounts of oxygen up to the depth of 20 meters is probably due to convective mixing of the water column and the current cyanobacterial bloom (cyanobacteria produce oxygen through photosynthesis), but it cannot be completely confirmed, as there are no data measurements of water quality in summer, when the reservoir was thermally stratified. For depths greater than 20 meters, oxygen decreases slightly, while for depths greater than 32 meters, there is a rapid drop. In the profile of V1, at the dam, near the bottom, nearly anoxic conditions are detected as a result of bacterial decomposition of organically precipitated matter. It is very important that water is evacuated from the reservoir bottom outlet because it contains the largest amount of phosphorus, whose presence is a prerequisite for development of cyanobacteria and other algae. Analyses of PWSU Kruševac (Grašić, 2013) indicate that the total phosphorus concentration in the bottom layer is 3 to 4 times greater than the average value for the whole of the reservoir. Significant amounts of dissolved oxygen and the absence of cyanotoxin in the water are the main reasons why there was no dead aquatic organisms spotted.

The vast majority of measured concentrations of chlorophyll *a* are in the range between 5 and 8 $\mu\text{g/L}$, which are relatively small concentrations, but being detected at greater depths, up to 30 meters (Figure 3c), means that the cyanobacteria occupied the entire volume of the lake, and that it is impossible to avoid them by changing the water intake elevation. Small concentrations of chlorophyll and dissolved oxygen saturation level that does not exceed 100 %, testifies the presence of cyanobacteria which are not significant producer of oxygen, but still able to synthesize organic matter under conditions of low temperature and low light conditions. For example, during the summer blooming of certain species of algae or cyanobacteria, oxygen concentration corresponding to the saturation of 150 % and more, could be detected.

The most of the measured pH values in the Vrutci reservoir were in a relatively narrow range between 8.2 and 8.5, which indicate an alkaline environment. Elevated pH values are the result of photosynthetic activity of cyanobacteria and geological composition of the basin of Djetinja River. In the profile V6, the highest value of pH, equal to 8.62 was measured. This indicates a relatively high alkalinity of tributaries (hard water), which was confirmed by chemical analysis of PWSU Krusevac.

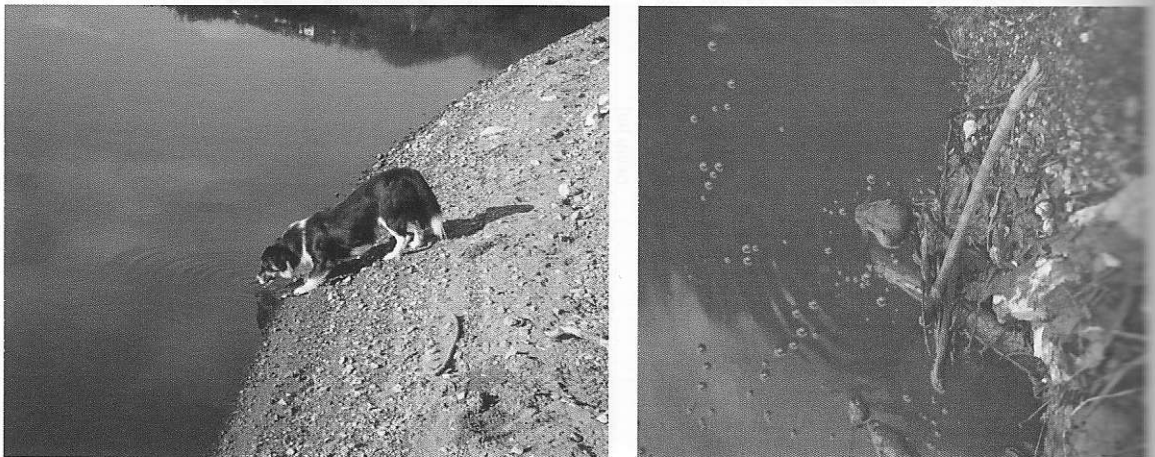
Figure 4. A dog drinking (reddish) water from reservoir Vrutci (left), and an otter (*Lutra lutra*) swimming upstream of the dam in a zone of thick layer of cyanobacteria.

On the December 28, the day of measurements, the reservoir was covered with a thick fog, and visibility was reduced. The next visit to the reservoir and tributary was organized on January 2, on a clear day. Elevation of the water level was at 614 m above sea level, which is 7 m lower than the design water level. The low water levels provided an insight into the lower littoral zone. Large amounts of sediment from torrential tributaries into the reservoir indicate an urgent need for the construction of torrential erosion control structures in the watershed. In Jokic meadows the dog was spotted while drinking water from the reservoir, and near the dam, an allegedly vital otter (*Lutra lutra*), dived and appeared out of the water, in a place where there was a thick layer formed from dead cyanobacteria (Figure 4).

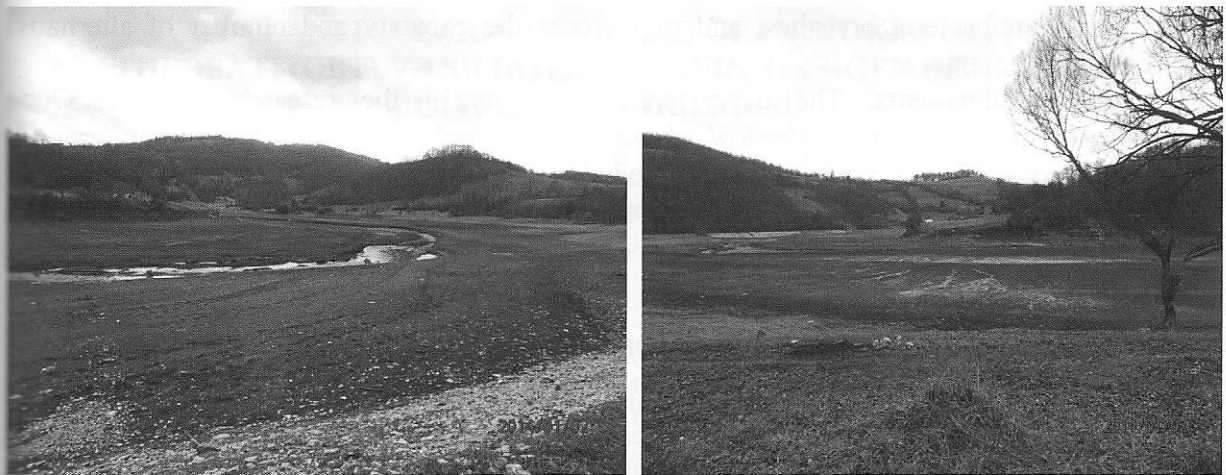
Figure 5. The most upstream part of the reservoir with sediment deposits revealed when the water level is lowered, either as an activity in flood management strategy, or due to hydropower utilization. This part of reservoir could serve as a habitat for water plants which can have an active role in intercepting incoming pollution and nutrients.

The upstream part of the reservoir is now without water, which provides insight into the bottom covered with sediment deposits (Figure 5), brought by river Đetinja from the watershed. Organic forms of nitrogen and phosphorus compounds are oxidized in air and transformed into inorganic forms, which are then available to all primary producers, including the cyanobacteria. During the period of high water, tributaries wash these layers, bringing them directly into the reservoir. It is therefore necessary to maintain the elevation of the water level as close to the normal elevation as possible, to allow establishing of populations of submersed macrophytes (aquatic plants) by biotechnical measures, or naturally. Macrophytes will assimilate nitrogen and phosphorus compounds more efficiently, provide shelter for fish, and help the restoration of a disturbed ecological balance. In the case of proliferation of macrophytes, their biomass is simply regulated by underwater harvesting, a practice that gives excellent results on the Sava Lake in Belgrade that despite the huge number of visitors in summer, manage to retain first-class ecological status. The most important objective of reservoir management is to avoid unnecessary changes of the elevation of the water table below the design level, which will provide storage for flood waves of 50 years return period, without overflowing.
