# Seismic Rehabilitation Techniques for Conserving and Managing Cultural Heritage of old City Fortress in Novi Pazar

**Keywords:** masonry buildings; authenticity; improvement; seismic strengthening; historic urban space; sustainable management

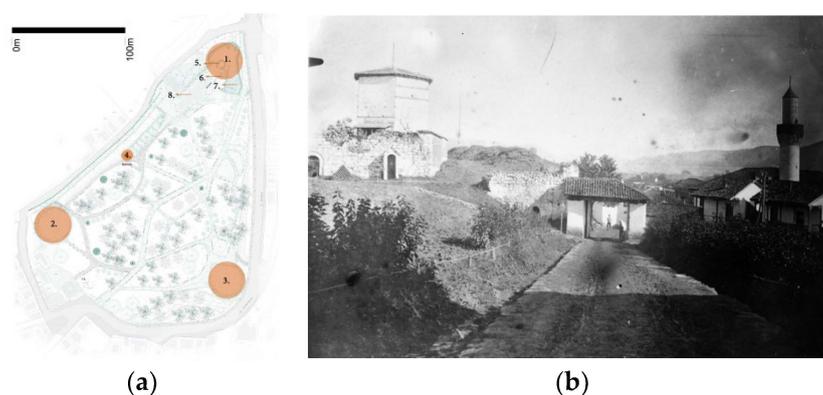
**Figure 2.** Details of city fortress. (a) Scheme of the facilities of the City Fortress—Actual state: 1—Northern Tabia; 2—Western Tabia; 3—Southern Tabia; 4—Tower Motrilja; 5—Tower Dzephana; 6—Gunpowder tower—Bartuthana; 7—Zindan; 8—Modern-day Library. (Drawing design: Lejla Zećirović). (b) Entrance into the Fortress (Photo source: Tower Dzephana, 1916, private archive of Vladan Vidosavljević).

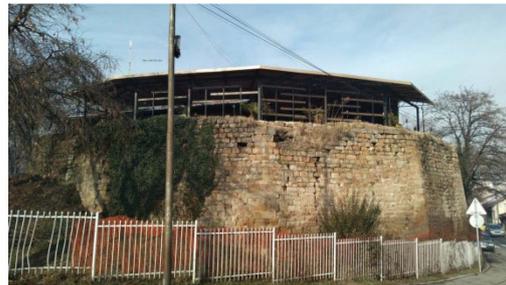
**Figure 6.** Southern Tabia: SW-NW view (Photo source: Lejla Zećirović).

Tabias were the main elements of defense, according to the principles of artillery fortifications (Figures 5–7).

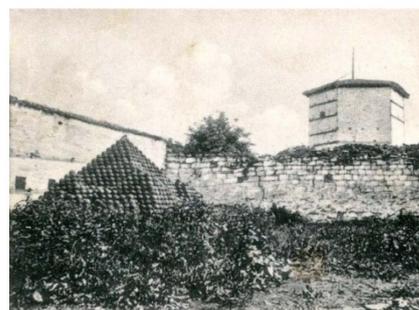
**Figure 8.** Old Tower Dzephana (Photo source: private archive of Vladan Vidosavljević).

The walls of the hexagonal Tower Dzephana (an ammunition storage facility) were discovered during the recent protective archaeological excavations at the fortress of Novi Pazar. Then it was established that this hexagonal tower was built at the beginning of the 17th century (Figure 8). In the coming period, it is planned to carry out a complete reconstruction of Tower Dzephana on the found remains.

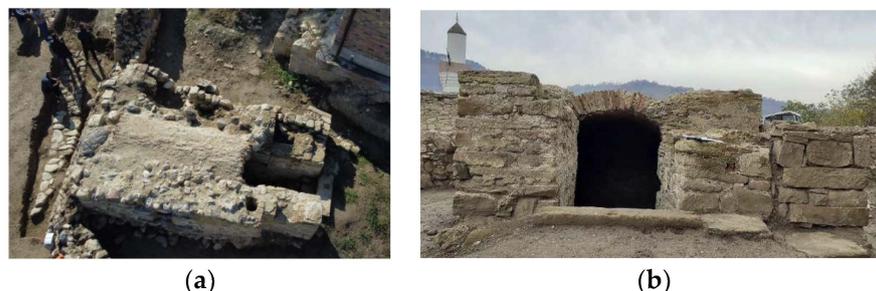
The Baruthana was the facility for storing gunpowder. It was recently discovered next to the remains of the Tower Dzephana. The facility is preserved, but the exact time of its construction is still unknown (Figure 9).

**Figure 9.** Baruthana. (a) Archeological site aerial view, (b) Baruthana entrance portal—view from outside (Photo source: private archive of Vladan Vidosavljević).

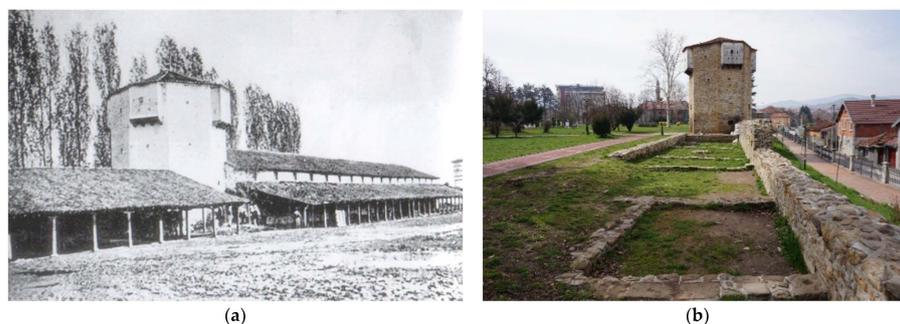
**Figure 10.** Tower Motrilja. (a) Archive photo—Tower Motrilja in 1918 (Photo source: private archive of Vladan Vidosavljević). (b) Present state of the tower with the remains of the Turkish barracks from the period of Abdul Aziz's reign (Photo source: private archive of Vladan Vidosavljević).

Of the numerous objects that were in the fortress, only Tower Motrilja or Sejr Kula (local name) has been preserved, an architecturally well-designed and shaped building with an octagonal base from which high walls were raised (Figure 10a). It served as an observation post with a wide field of vision to secure the ramparts from potential attackers. The tower is located between the northern and western Tabias, it is about 15 m high, and in the upper zone of the walls there are four musharabiyas (Turkism, loopholes), circular loopholes of smaller dimensions as well as some rectangular ones (Figure 10b).

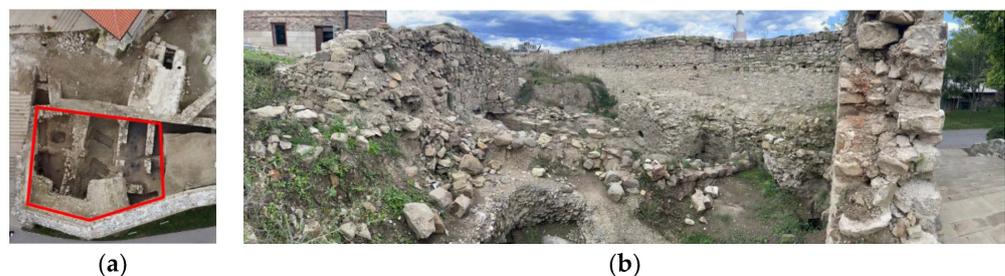
**Figure 11.** Excavation of the dungeon. (a) Aerial view of the site. (b) Present state of the remains of the dungeon (Photo source: Lejla Zećirović).

The archaeological excavation conducted in 2020 revealed the following: The walls of the dungeon (zindan, Turkism), and the corridor leading to it are not structurally connected to the walls of the Tabia, which were not built at the same time [12]. From the outside, the dungeon shows several construction interventions during different time phases (Figure 11). The northwest corner of the entrance to the dungeon has been rebuilt, as well as its entire western wall, which can also be seen from the inside. The outer sides of the dungeon walls are rather crudely executed. The walls were made of broken and hewn blocks of sandstone, river pebbles, and bricks connected with lime mortar. The binding material was lime mortar. The space between the walls of the dungeon and the western and northern profiles was filled with a large amount of cinders and ashes as well as burnt fragments of bricks and roof tiles, which testifies that the building was destroyed by fire. The floor was most likely made of lime plaster, but it was completely burnt and its appearance is preserved to a lesser extent on the inner side of the south wall.

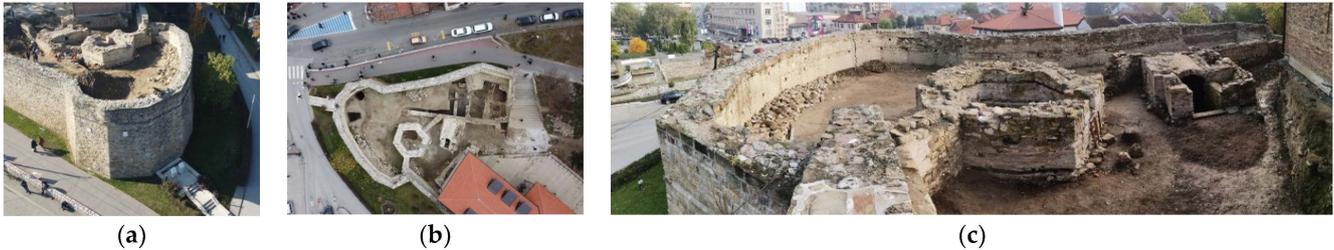
**Figure 12.** The remains of the tower Dzephana found on the northern Tabia, next to the dungeon. (a) NE-SW view; (b) aerial view; (c) on-site view (Photo source: private archive of Vladan Vidosavljević).

The Tower Dzephana is a hexagonal building of smaller dimensions at the base, next to the northern Tabia of the fortress. Based on the remains (Figure 12) found by archaeologists from Novi Pazar, Sjenica, Belgrade, and Sarajevo, this hexagonal tower was built at the beginning of the 17th century, and not, as previously thought, in the 18th century (based on written documents) [12].

The entrance to the tower was located inside the southwestern wall and was 0.70 m wide. The tower was built from hewn blocks of sandstone and trachyte and river pebbles bound with lime mortar, and the filling consisted of pieces of sand and trachyte, river pebbles and fragments of bricks with lime mortar. The structure of the walls was strengthened by placing wooden beams in the walls of a rectangular cross-section, along with semi-shaped beams connected with iron wedges which were placed transversely in relation to the walls. The outer walls of the tower were plastered and painted, and the inner walls were only plastered. Two phases are visible on the floor surface of the tower, the younger lime mortar and the older stone slabs. The foundations of the tower were made of river pebbles arranged in a regular sequence in four rows and flattened from the outside in relation to the walls. The height of the foundation of the tower is about 1.00 m.

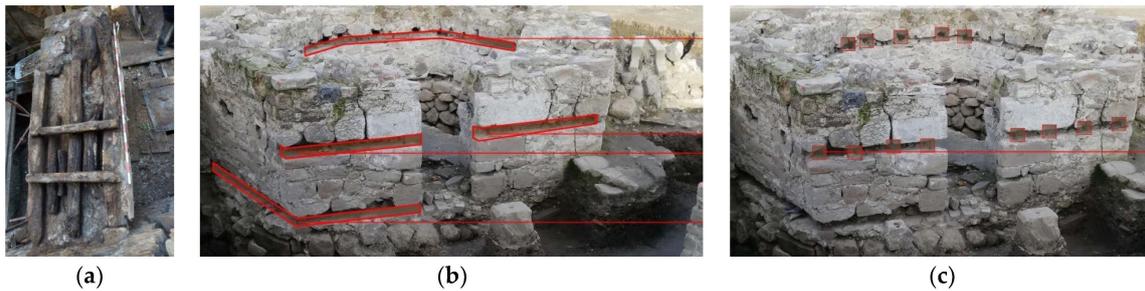
**Figure 13.** The remains of the tower Dzephana. (a) Wooden construction for reinforcement (from Hilandar monastery, identical to the construction of Tower Dzephana). (b) Molds of the longitudinal beams on Tower Dzephana. (c) Molds of the transversal beams on Tower Dzephana (Photo source: private archive of Vladan Vidosavljević).

The authenticity of the tower is reflected in the completely preserved architectural structure of an octagonal shape, with four cantilever outlets for musharabiyas (loopholes), the only ones preserved in this area (see Figures 12 and 13). The first conservation and restoration works were carried out in the eighties of the last century, when the stages of external plastering were removed and cleaned and plastered (filling the connections with lime mortar and lime milk using a special rubbing technique), the musharabiyas were rebuilt and again plastered and painted. The roof structure has kept its original shape, all the original beams that were in good condition have been kept, those that have worn out have been replaced with beams treated in such a manner as to not differ from the originals (neither in terms of color nor texture do they spoil the appearance of the old beams). Tiles were used as roof covering [10]. Recently, the reconstruction of the building of the tower was carried out according to the conditions set by the Republic Institute for the Protection of Cultural Monuments. The appearance of the tower has not been changed; it has remained authentic to its origin.

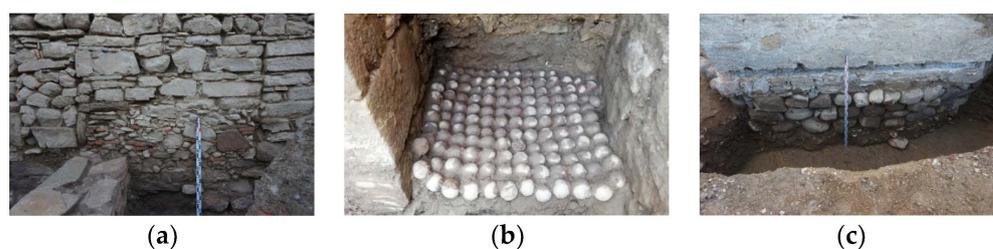
**Figure 14.** The use of the various stone stack for the construction of the city fortress. (a) Sandstone. (b) Cannonballs. (c) Brick and river pebbles (Photo source: private archive of Vladan Vidosavljević).

As already mentioned, interventions were carried out on the destroyed parts of the building with identical materials, whose characteristics are known and confirmed, more commonly than with new materials, as they could cause a problem due to the lack of information about the properties and compatibility of the behavioral mechanisms of these materials. The use of inappropriate stone can result in significant damage to heritage [27]. The replacement stone on the damaged parts of the building should be of the same type as the original or the closest possible equivalent, with knowledge of its characteristics that should correspond to the original stone [28]. During the construction of the medieval fortification, the following types of stone were used (Figures 14 and 15):

- Novi Pazar sandstone: it is formed by binding sand, using natural binding materials. The color of this natural stone depends on many factors, primarily on the color of the binder used to create the stone: in yellow and brown, red, gray, or green shades. For this reason, the use of this stone was very diverse. Today, some of its types are also used when making foundations, and it is very resistant to temperature differences, especially when it comes to high temperatures, so it is often used to cover fireplaces with this stone, or exterior walls, and the like.

- Andesite appears mainly in the form of large masses (outflows), columnar, or bank-like secretions.
- River pebbles are also widely represented in the area of Novi Pazar, in different colors and granulations.

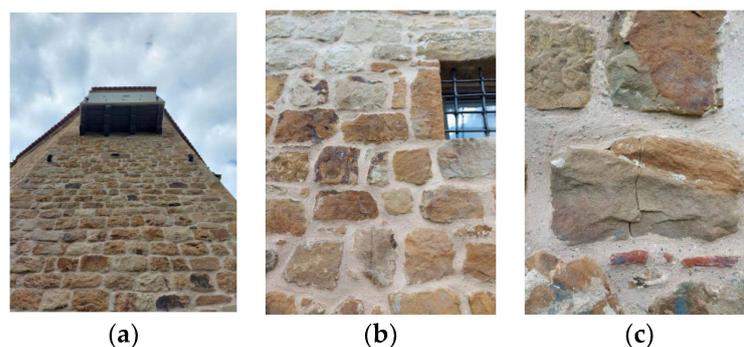
**Figure 15.** The use of the different types of stone on the Tower Motrilja. (a) On-site view. (b) Stone stack detail. (c) Deteriorated elements in the tower (Photo source: Branko Slavković).

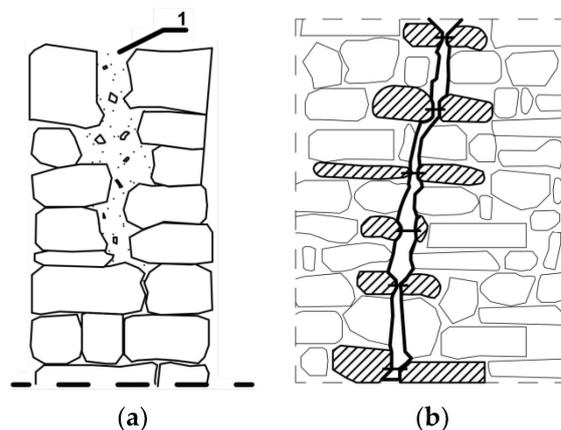
**Figure 16.** Technical details: (a) Stone wall with points of mortar injections. (b) Clamps or fittings perpendicular to the cracks in the wall (Drawings: Lejla Zećirović).

at a depth of 50 mm, fixed with cement mortar. Cracks are filled with cement mortar along the entire length. The tubes are plugged and then, by opening the plugs in pairs, the crack between the adjacent tubes is washed or blown out. Injecting is done under low pressure, from the bottom up, and the emulsion starts to flow on the first upper tube [36]. Instead of tubes, the grouted wall can be strengthened by inserting clamps at the grouted places (Figure 16b).

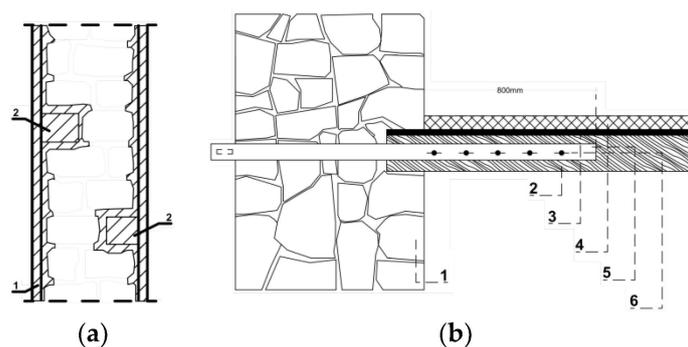
**Figure 17.** Technical details: (a) 1—Reinforcement with the reinforced cladding; 2—connection with the wall by concrete “niches”; (b) connection of a wooden mezzanine structure to a stone wall: 1—existing stone wall; 2—existing wooden beam; 3—wooden mat; 4—new cement screed; 5—steel strip; 6—elsers (Drawings: Lejla Zečirović).

Composite materials are materials composed of two or more components, where the mechanical characteristics of the material depend on the mechanical characteristics of the components. In practice, most composite materials are composed of a base material (matrix) and reinforcement (a material that provides strength). In construction practice, epoxy resins are most often used as a matrix, and glass, aramid, or carbon fibers as reinforcements. Steel clamps, reinforcement, or reinforced concrete beams can be installed directly on the cracks (Figure 17a). Cavities can also be filled with concrete, thus strengthening the entire wall. In the case of significantly damaged walls, it is often necessary to replace entire parts of the wall mass, where it is first necessary to temporarily support the structure located above the damaged wall. In the case of visible dislocations of a part of the wall, the existing wall should be removed and a new one made of the same material should be rebuilt. One of the ways to rehabilitate and strengthen walls damaged by an earthquake is reinforcement. The reinforcement bar is attached to the pre-cleaned wall that has open joints and cracks, by inserting vertical and horizontal ring beams, while injecting the filling mass. Cement mortar M30 is applied to the reinforced wall in a thickness of 3 to 5 cm. Another way is to install concrete “niches” (Figure 17b). In order to increase the rigidity of the existing floor structure, reinforcement is recommended, with the use of steel clamps on both sides of the walls (attached to the wooden floor structure). Damaged and dislocated walls should be rebuilt with the same material but of better quality or reinforced with ring beams [48]. Part of the facade can be connected to the rest of the building, using wooden beams—tensioners and iron anchors, so-called “keys” (Figure 17b). In this way, during an earthquake, due to stress concentration, the creation of cracks and the collapse of the walls would be prevented. Blocks of stone can be connected to each other with metal anchors, in order to act on the principle of a chain [37].

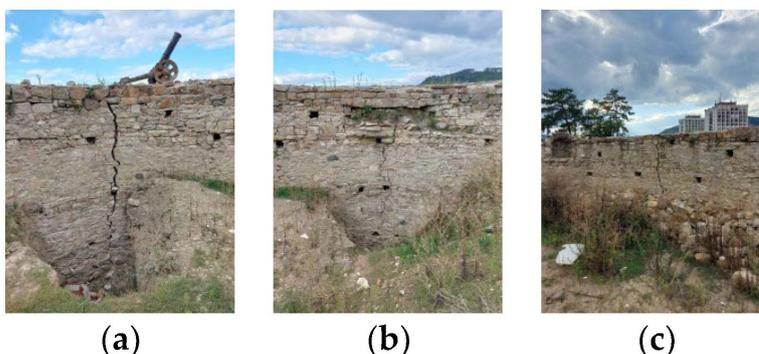
**Figure 19.** Cracks on the walls of the fortress—northern Tabia. (a) Inside view—northern position; (b) inside view—eastern position; (c) inside view—western position (Photo source: Branko Slavković).

Before proceeding with the rehabilitation of cracked walls, it is necessary to assess the extent of mechanical damage in cracked structures, detect the presence of cavities and defects, assess moisture content and capillary growth, detect surface deterioration, and assess the mortar and the mechanical and physical properties of the stone.

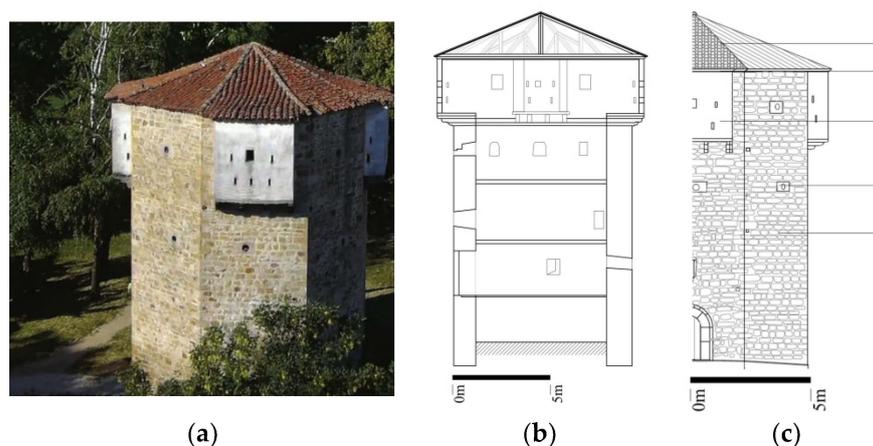
**Figure 20.** Tower Motrilja. (a) On-site aerial view (Photo source: private archive of Vladan Vidosavljević). (b) Cross-section of the tower. (c) Detail of the materialization of the façade: 1—limestone stack; 2—circular loopholes; 3—brickworks; 4—profiled roof cornice; 5—roof tiles stack (Drawings: Lejla Zećirović).

Using the regulations for eliminating the consequences of the earthquake, the practice and suggestions of the Institute for the Protection of Cultural Monuments, the proposed and implemented actions for its recovery are shown in the following text. In order to preserve the original features of the building and solve the construction of the tower, it was necessary to keep the shape of the mezzanines and replace worn-out material due to the introduction of a modern function into the building (Figure 20).

Tower Motrilja has five floors (Basement + Ground +2 Floors +Attic), built in a massive structural system, with facade walls 1.30–1.50 m thick, made of stone, with lime plaster as filling.

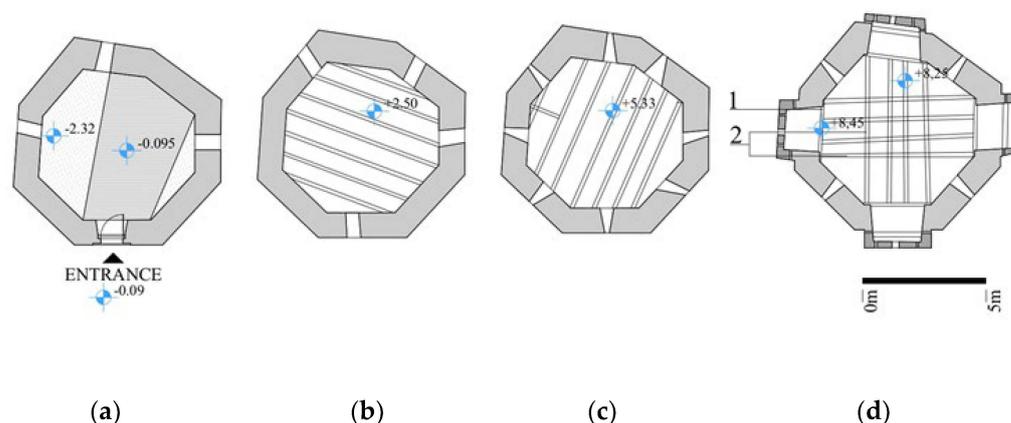
**Figure 21.** Base of the Tower Motrilja. (a) Ground floor. (b) First floor. (c) Second floor. (d) Attic: 1—wooden beam; 2—slat; (Drawings: Lejla Zećirović).

The foundation of Tower Motrilja is polygonal (octagonal), with a total width of about 8.30 m (Figure 21). The constructive system of Tower Motrilja consists of massive walls, which are also facades, 13.5 m high, stiffened by mezzanine wooden ceilings stretching in two directions, alternately by floor levels. In the last floor, triple multiplication of wooden beams is planned for the formation of musharabiyas. The walls of the musharabiyas are built with bricks, due to their lighter weight, and after plastering they will be painted white.

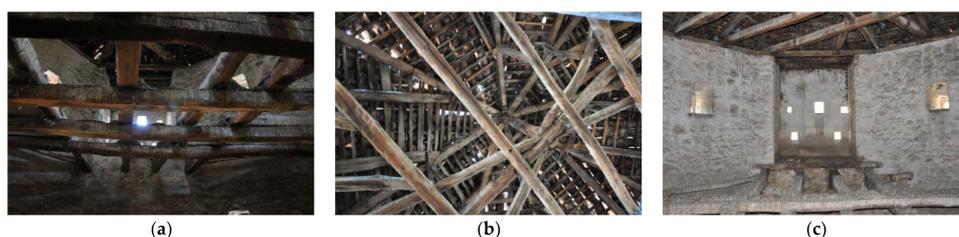
**Figure 22.** Tower Motrilja. (a) New mezzanine construction. (b) Roof construction. (c) Detail of the mezzanine (Photo source: private archive of Vladan Vidosavljević).

The wooden mezzanine structures are cross-oriented on the floors, they extend vertically in relation to each other. The footings are placed crosswise on two adjacent floors in height, as in the existing structure where it is made of wooden beams. On the floor below the attic, the existing subfloors are retained, which extend in both orthogonal directions on this mezzanine structure. On the part of the staircase, they rely on new beams of the same dimensions and on the subfloors of all lower levels, accepting the new designed load while retaining the existing wooden beams. The central mezzanine structure is designed entirely from pipes with a rectangular cross-section, dimensions  $200 \times 120$ ,  $t = 8$  mm, according to the calculation of the two most heavily loaded parts and the subfloor of the largest span. Due to the repurposing of the building and meeting the minimum conditions of fire protection, as well as due to the modern function assigned to it, it is necessary to replace the existing wooden mezzanine structure with a new, steel structure, with the obliging construction of a new staircase made of modern materials: steel and glass, all according to the completed and accepted project and static calculations for all parts of the building that is subject to rehabilitation and reconstruction. The new steel structure consists of steel beams—pipes with a rectangular cross-section—which are oriented across the floors, i.e., perpendicular to the direction of extension on the adjacent floor (Figure 22).

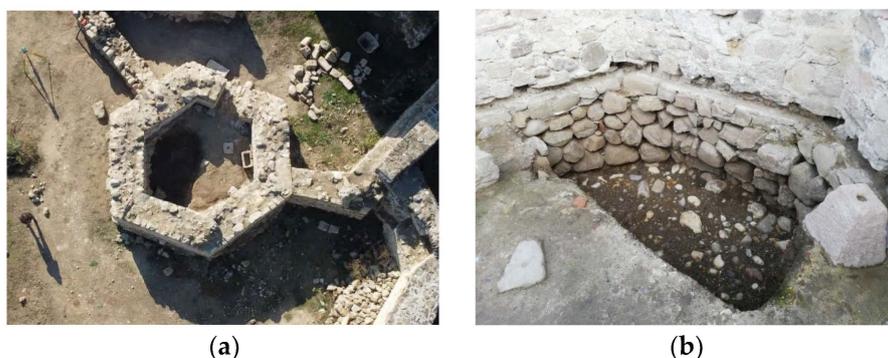
**Figure 23.** Archeological site of Tower Dzephana. (a) Aerial view. (b) Detail of the foundation (Photo source: private archive of Vladan Vidosavljević).

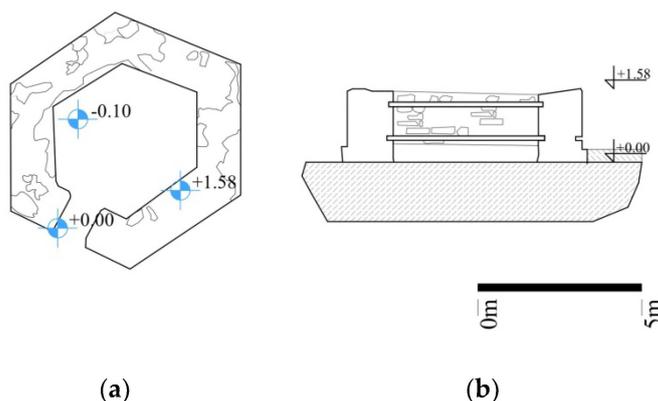
**Figure 24.** Drawings of the Tower Dzephana. (a) Base—foundation of the tower. (b) Cross—section of the tower (Drawings: Lejla Zećirović).

The experts of the Institute for the Protection of Cultural Monuments proposed measures and made the technical designs for the reconstruction of the Tower Dzephana (which are under consideration), based on the preserved data of archival material. The existing preserved remains of the tower are about 2 m high. Reconstruction in two phases is recommended. After the restoration and conservation of the original remains, the tower will be renovated and expanded with authentic materials (stone, wood) based on the existing structure. The reconstruction project of the Tower Dzephana is ongoing and proposals for its future appearance are being considered. The height of the masonry in authentic

material is about 9.0 m. One of the ideas is to build a wooden platform on the inside of the rampart walls from which the tower will be accessed and which will have the function of a viewpoint towards the city: towards the new and old part of the bazaar. It was suggested that the last rows, i.e., the crown of the tower, should be bricked unevenly, in order to leave the impression of damage, i.e., a ruined tower, the appearance of which is evidenced by photo documentation from the Second World War (Figure 24a). The building will have three floors, and the proposal is for the last floor to be made of glass. The Tower Dzephana will have a completely new, modern purpose, which justifies the proposal of using modern materials—glass and steel. The suggestion is that the bricking should be done in regular rows with broken stone with two faces and the core is filled with hewn stone. Horizontal wooden beams would be placed at certain distances. The second stage of the reconstruction would be the construction of a glass floor–lookout (Figure 25b,c). The construction of the platform and observation deck made of steel, with primary and secondary supporting profiles, according to the static calculation, was proposed. New mezzanine structures should ensure an even distribution of seismic impacts on the vertical elements of the structure. Three types of materials could be clearly distinguished on the building: the remains of the medieval tower made of original stone, reconstructed parts of the tower with uneven ends made of replacement stone, the most similar to the original, and glass on the final floor of the tower. It is necessary to make an assessment of the condition of the foundation and a calculation for the necessary reinforcements, because the foundation should accept both the existing and the additional vertical load, resulting from the mass of the upgraded part, but also from seismic influences. The combination of old and new materials, the contrast between the glass structure and the authentic “layer” of the medieval architecture of the fortress, creates the dynamics of the entire composition.

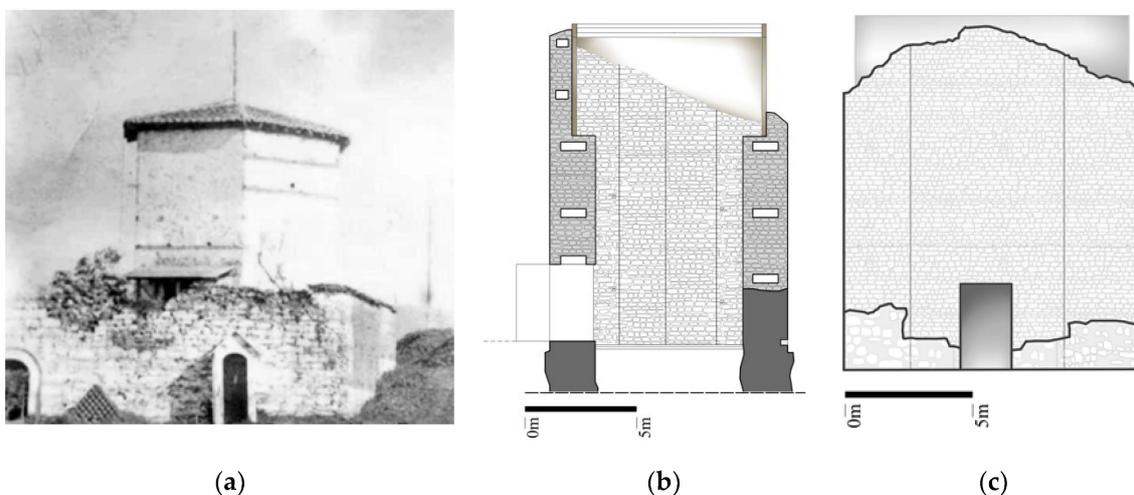
**Figure 25.** Tower Dzephana. (a) Tower Dzephana before the demolition, called Ahmed Aga’s tower (It is assumed that he rebuilt it) (Photo source: private archive of Vladan Vidosavljević). (b) Cross-section of the tower Dzephana—proposal. (c) Detail of the materialization of the façade—proposal (Drawings: Lejla Zećirović).
